**Ten Year Renewal and Replacement Plan  
and  
Twenty Year Estimated Capital Expenditures  
for  
Current and Recommended Plans**

**Newport/Pell  
and  
Mount Hope Bridges**

### **NEWPORT/PELL BRIDGE**

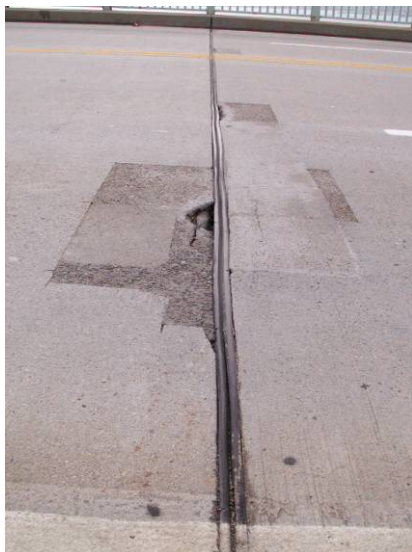
**Photo No. 1.2**

**Description:** Span 5 West Westbound Travel Lane. Concrete shows previous repairs and new rupture at expansion joint.

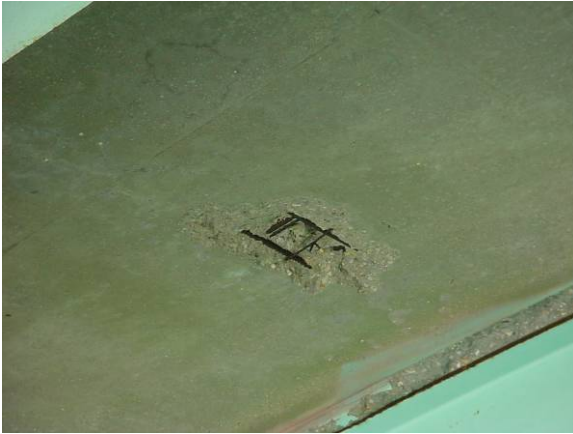
**Photo No. 2.1**

**Description:** West Side Span, Panel 33 West. A pop-out (spall) on the bottom surface of the concrete deck with exposed reinforcing steel.

corrosion on the reinforcing steel that is embedded in the concrete. The surface layers of the steel expand as they rust. As the steel expands it exerts a force that causes the concrete to separate, creating a void within the pavement or causing the surface concrete to fail, exposing the reinforcing steel (see Photo No. 2.1). These voids are enlarged during the winter season as moisture fills the void and expands when the water freezes.

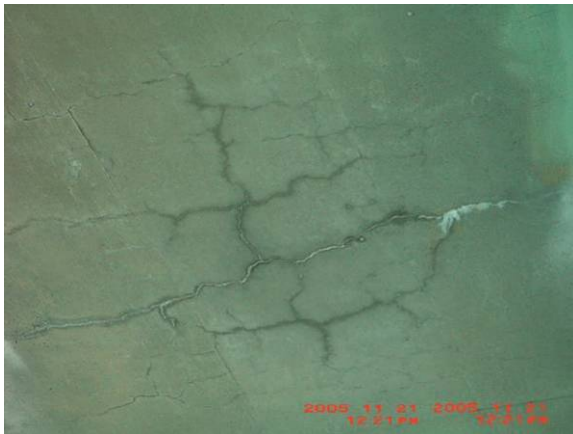
**Photo No. 2.2**

**Description:** East Side Span. Crack formation on the bottom surface of the concrete deck with efflorescence (white salts in the cracks).

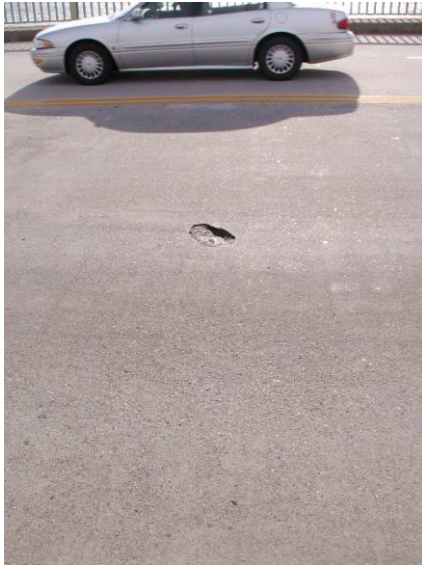
**Photo No. 4.1**

**Description:** Twelve inch diameter spall in the pavement surface.

At a minimum, the annual program includes spall repair, which is the replacement of pop-outs that appear on the top surface of the pavement (see Photo No. 4.1).

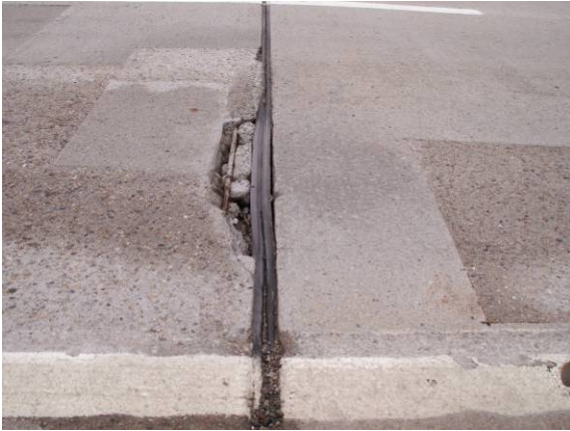
**Photo No. 5.1**

**Description:** Span 5 West, Westbound Travel Lane. Concrete rupture at expansion joint.

The roadway deck and expansion joint components experience significant wear due to the impact of vehicles crossing the bridge, particularly the heavy truck traffic. The concrete is less resilient and is prone to cracking at the joint locations (see Photo No. 5.1).

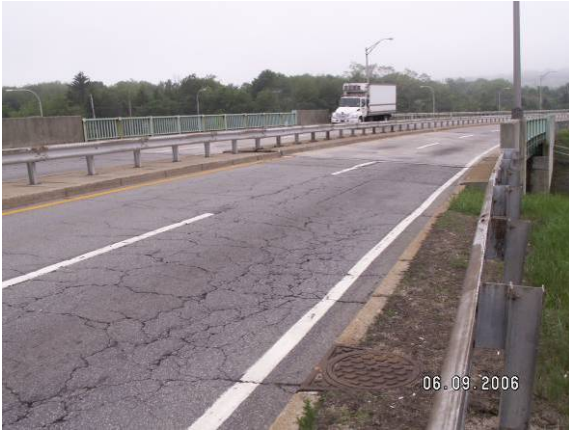
**Photo No. 6.1**

**Description:** Westbound West Approach at Structure "E". Cracking and settlement of the pavement in the westbound travel lane.

The condition of the asphalt in the westbound lane was characterized by surface cracking and settlement of the pavement (see Photo No. 6.1).

This plan assumes that the two westbound lanes are repaved in years 1-10 where pavement has cracked and settled.

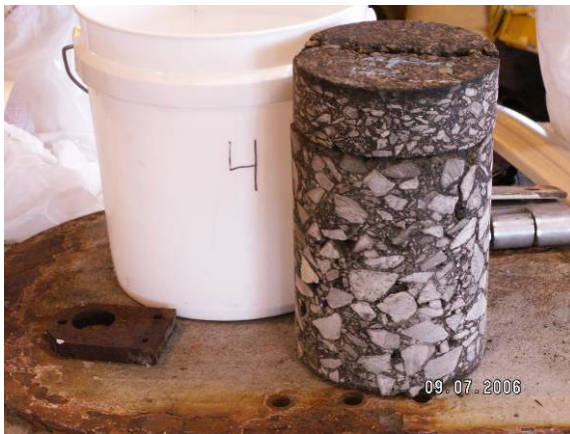
**Photo No. 6.2**

**Description:** Asphalt core removed from the west approach for analysis.

Asphalt cores revealed that the eastbound lanes require only shallow-depth overlay replacement of the asphalt (see Photo No. 6.2).

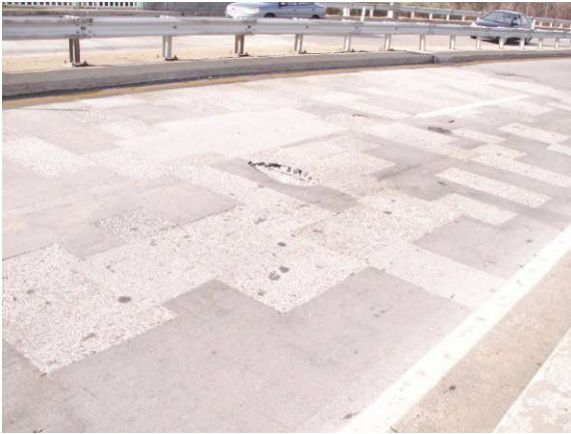
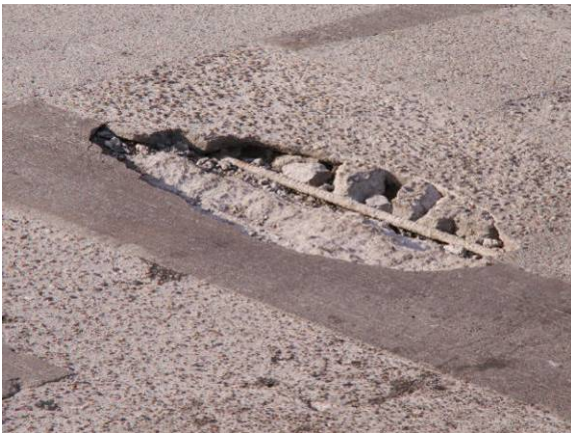
**Description:** Structure "E", Westbound Lanes. General view showing patch deck repairs and a spall in the westbound travel lane.

**Description:** Structure "E", Westbound Lanes. Close up view of a spall with exposed reinforcing steel in the westbound travel lane.

The existing reinforced concrete deck is in poor condition (see Photo Nos. 7.1 and 7.2).

The majority of the riding surface has partial depth patch repairs and additional partial depth concrete patching is typically required on Structure "E" on an annual basis.

The study has found that the chloride levels in the bottom portion of the Structure "E" deck are not so high as to preclude a partial depth deck replacement approach to extend the life of the deck, provided this occurs in a timely manner. The

This plan assumes full-depth deck replacement for Structure "E" carried out in plan years 1-10.

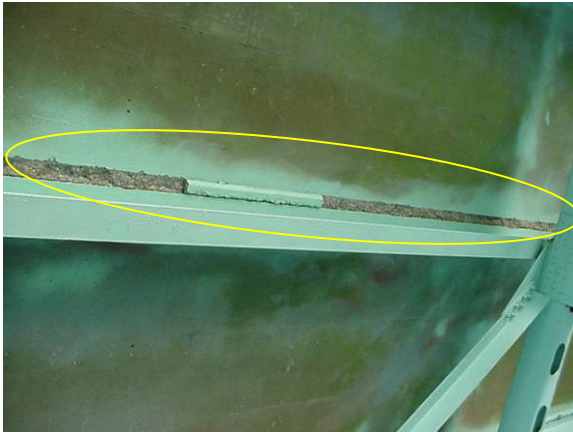
**Photo No. 8.1**

**Description:** *Loss of concrete haunches below the concrete deck.*

cracking and falling into the channel below. This condition poses a hazard to boat and ship traffic.

RITBA in-house maintenance staff, bridge inspectors, and contractors remove loose haunches as they are found while performing tasks near the underside of the deck. The Ten Year Plan includes costs for haunch removal packaged with other work that is performed in the area of the haunches.

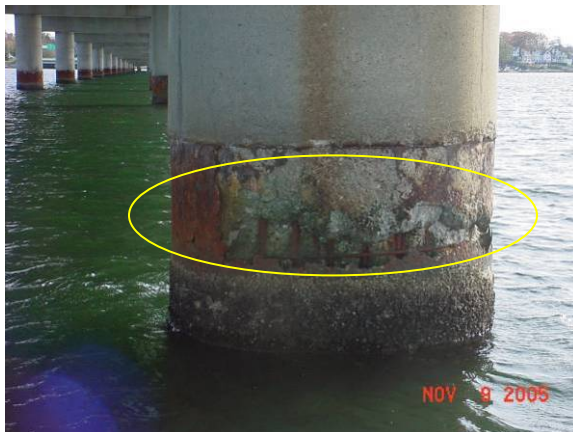
**Photo No. 9.2**

**Description:** Pier 21 East, South Column – Steel jacket has deteriorated, the concrete is missing, and the reinforcing steel within the column is exposed.

Future repairs locations have been identified or are anticipated based on deterioration of materials over time on other portions of the bridge (see Photo No. 9.2).

This plan assumes that additional concrete patch repairs to the piers and anchorages will be required in years 1-10.

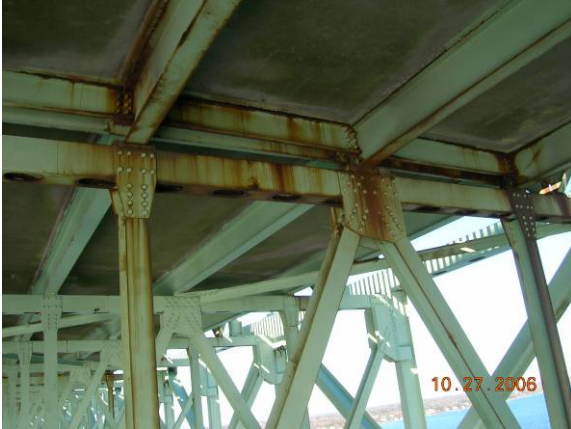
**Photo No. 11.1**

**Description:** Main Span, Panel Point 54 East. Floor truss at expansion joint with surface rust and corrosion visible on floor truss elements, stringers and diaphragms.

The effective life of the paint system on a single bridge varies significantly as well. Paint on steel members located beneath a leaking deck joint, as exhibited in Photo No. 11.1, deteriorates more rapidly than paint that is protected from storm runoff, as shown in the background of the same photo.

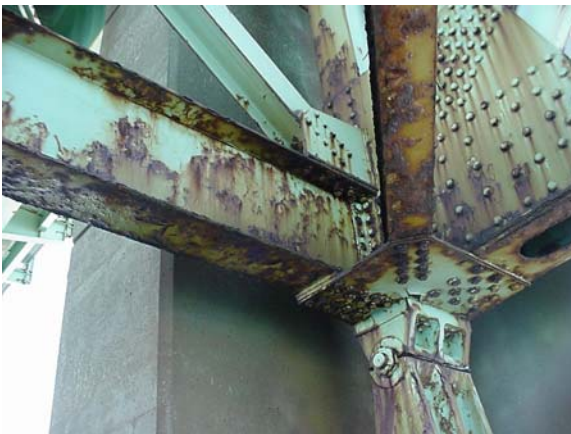
**Photo No. 11.2**

**Description:** Span 5E. Paint failure and surface corrosion on steel truss and bracing members.

Photo 11.2 shows the typical condition of steel under previously open finger joints at deck truss spans. As part of Contract 01-7, drainage troughs were installed under these joints to stop water from falling onto and rusting the steel below. This work was intended to be performed prior to painting to ensure that newly painted steel would not be subjected to continued corrosion from the open joints.

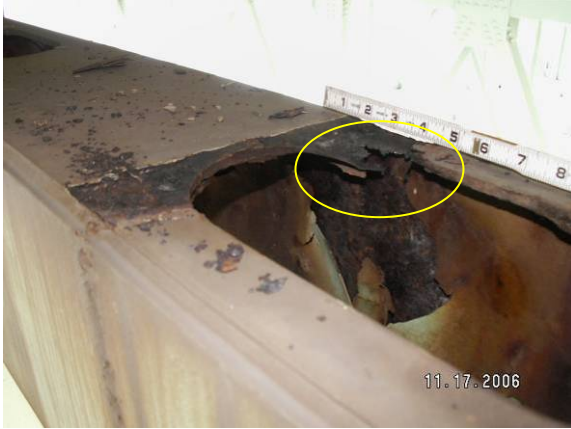
**Photo No. 11.3**

**Description:** *East Side Span, Panel Point 5 East. Section loss to top flange of floor truss top chord adjacent to hand-hole.*

In extreme instances members with failed paint systems may need to be rebuilt or replaced in order to perform their intended function. The corrosion at the hand hole in the truss member in Photo No. 11.3 shows paint failure that resulted in corrosion that has eventually resulted in localized 100% loss of plate thickness. This localized condition is not currently a structural issue, however continued deterioration such as this can result in requiring structural repairs in addition to painting.

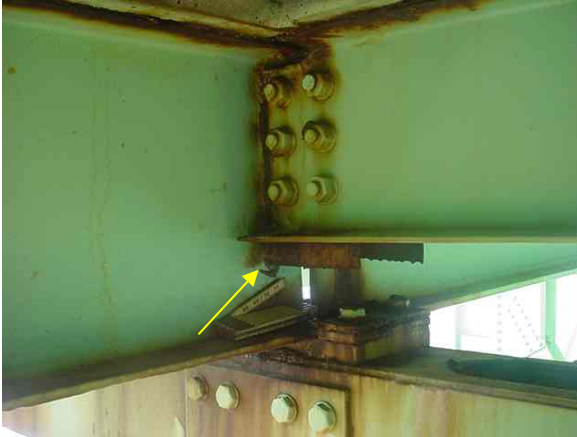
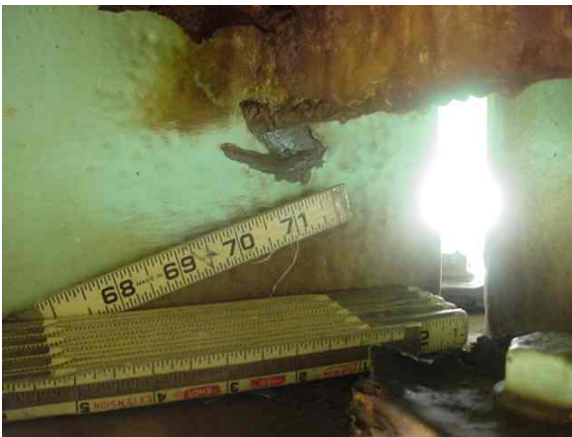
**Description:** Span 1, Panel Point 48 East, Stringer S8. Crack has formed below the diaphragm connection plate weld on Stringer S8.

**Description:** Span 1, Panel Point 48 East, Stringer S8. . Close up view of crack that has formed below the diaphragm connection plate weld on Stringer S8.

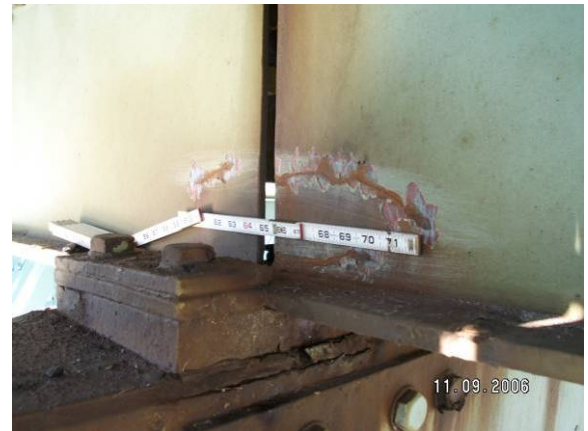
**Photo No. 12.3**

Subsequently, during the 2006 Annual Inspection, 30 percent of the locations with this type of weld exhibited similar cracks (see Photo No. 12.3).

**Description:** West Side Span, Panel Point 25 west, Stringer S2. Stringer exhibits a 6-½ inch long crack on the near side below the diaphragm connection plate weld located on the far side. A 4 inch long crack has formed above the bottom flange fillet.

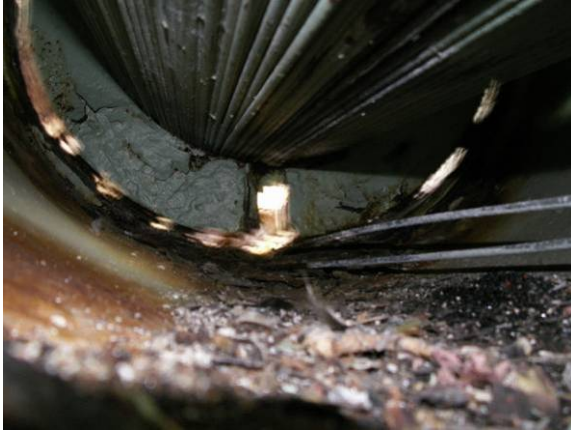
**Photo No. 13.1**

**Description:** East Anchorage, North Splay Chamber, Cable Entry Portal. Two of the north cable wires are broken.

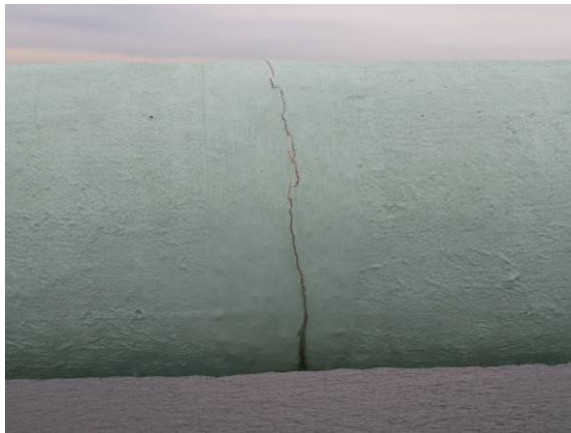
**Photo No. 13.2**

**Description:** Main Span, North Cable. Circumferential crack in cable wrapping.

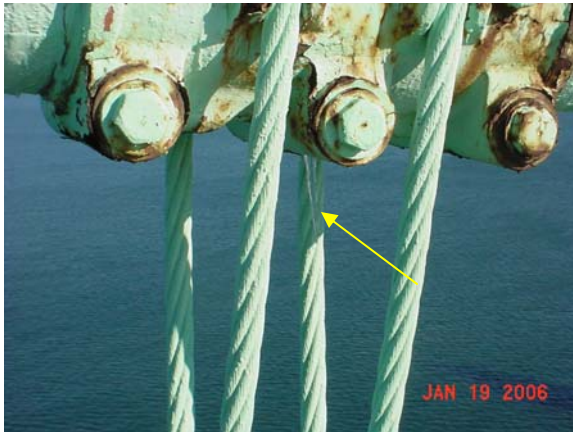
**Photo No. 13.3**

**Description:** North cable, West Side Span, Cable Band 1NW – Peeling paint and surface corrosion on bottom surface of the cable band.

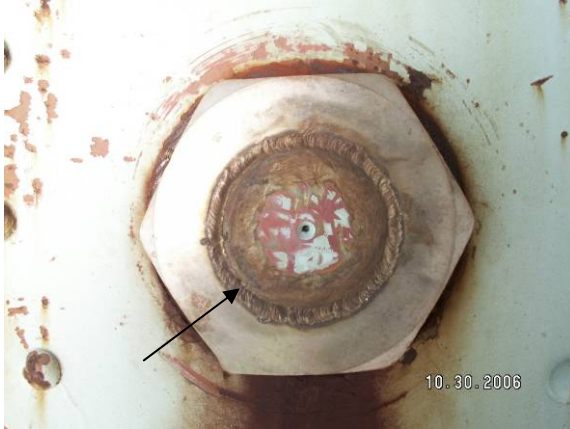
**Photo No. 14.3**

**Description:** Tower 1 West, Northwest Compression Link, Upper Inside Pin. The pin nut has been replaced and welded to the pin.

Differential rotation allows the pin nuts to loosen. In two instances, the nut drifted and backed off the pin completely. In each case, a new nut was installed and welded to the pin.

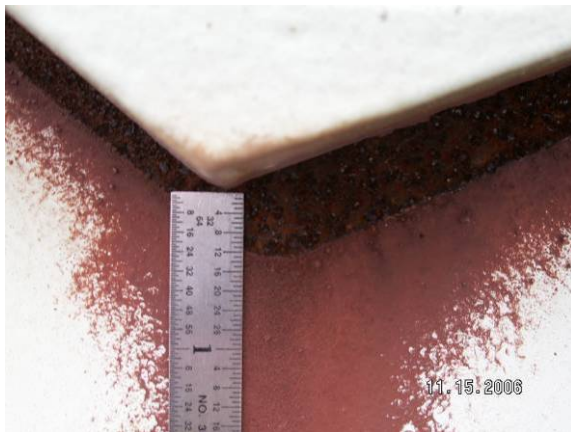
**Photo No. 14.4**

**Description:** East Tower, Southwest Compression Link, Upper Outside Pin Nut. The pin nut exhibits nominally 1/2 inch vertical displacement

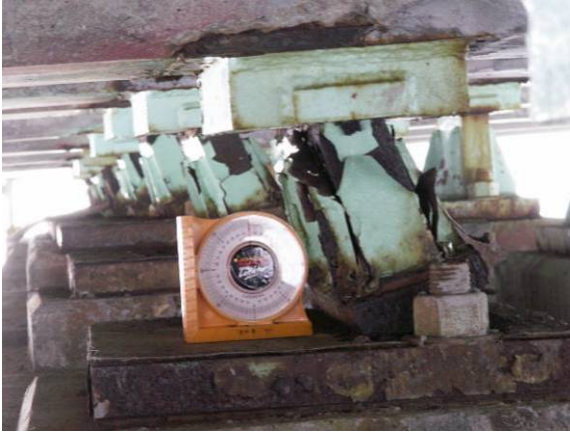
**Photo No. 15.1**

**Description:** Pier 30 East, Bearing 7. Bearings The expansion bearings in Span 30 East (on east side of pier) are overextended.

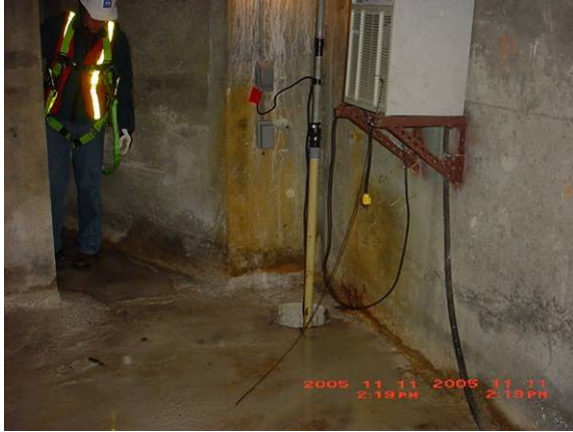
**Photo No. 17.1**

**Description:** West Anchorage, North Socket Room, Sump. Two inches of standing water adjacent to sump.

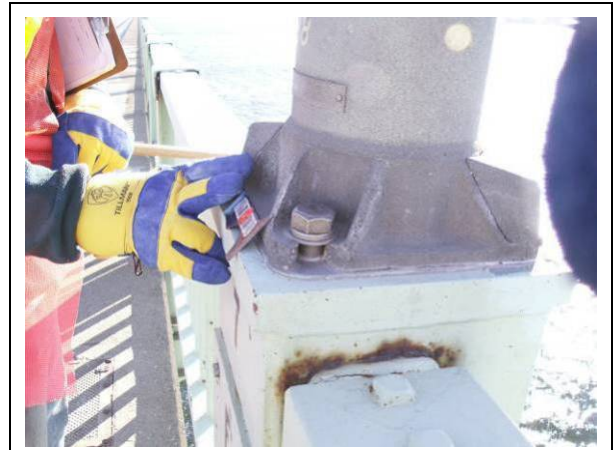
**Photo No. 17.2**

**Description:** Span 7 East, South Fascia, Light Pole 88. Light pole exhibits cracks and missing piece of base on the northwest corner.

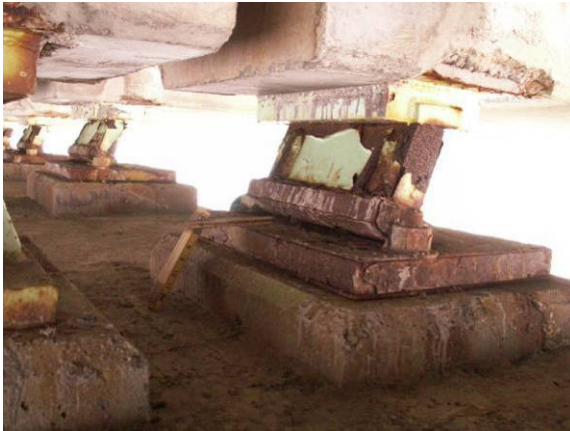
**Photo No. 24.2**

bearings have been observed to be frozen in an overextended position (see Photo No. 24.2) due to age, loss of lubrication, and build-up of rust around the base of the bearing designed to tilt, all preventing the expansion bearings from operating properly.

**Description:** Pier 23 East, Span 25, Expansion Bearings. Overextended bearings.
