**Ten Year Renewal and Replacement Plan  
and  
Twenty Year Estimated Capital Expenditures  
for  
Current and Recommended Plans**

**Newport/Pell  
and  
Mount Hope Bridges**

### **NEWPORT/PELL BRIDGE**

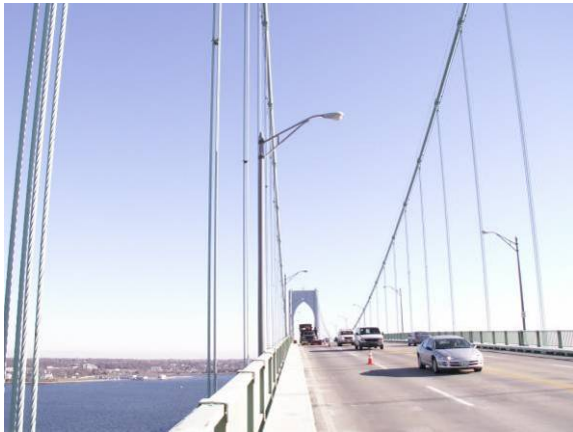
**Photo No. 1.1**

**Description:** A view of the westbound traffic on the main span roadway.

The original concrete cast-in-place roadway deck is over 37 years old and has continually been inspected and repaired as part of a preventive maintenance program (TYP Items 2,

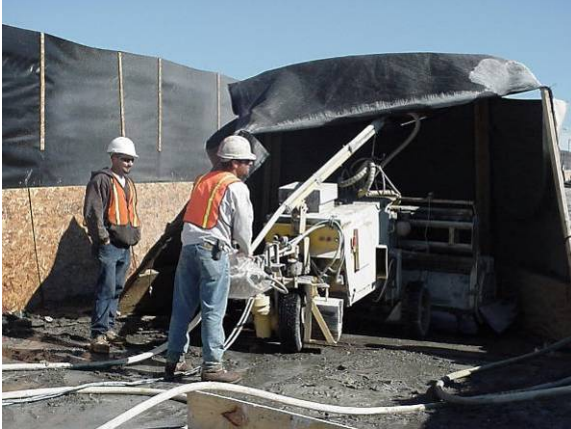
**Photo No. 3.1**

**Description:** *Hydro-demolition of the upper three inches of the roadway surface for the partial depth pavement replacement in the west approach spans.*

Partial depth replacement of the concrete deck is an economic alternative to replacing the entire deck. The costs and time when lanes are out of service for revenue customers are significantly reduced.

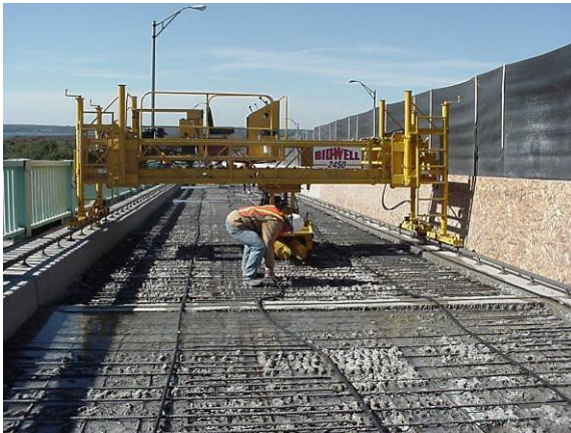
**Photo No. 3.2**

**Description:** *Preparing reinforcing steel for partial depth replacement of the concrete pavement in the west approach spans. The concrete has been removed to a depth of about 3 inches (below the top level of reinforcing bar).*

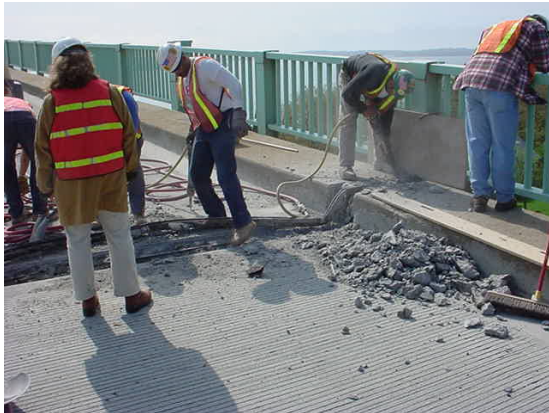
**Photo No. 5.2**

**Description:** Preparation of an expansion joint for a partial depth concrete repair.

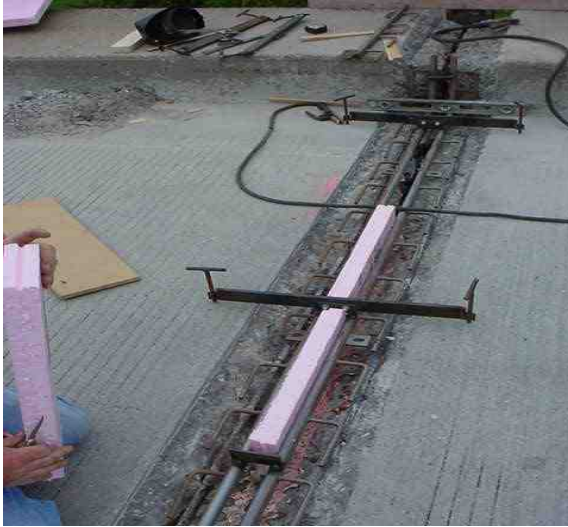
**Photo No. 5.3**

**Description:** Preparation of an expansion joint for a partial depth repair.

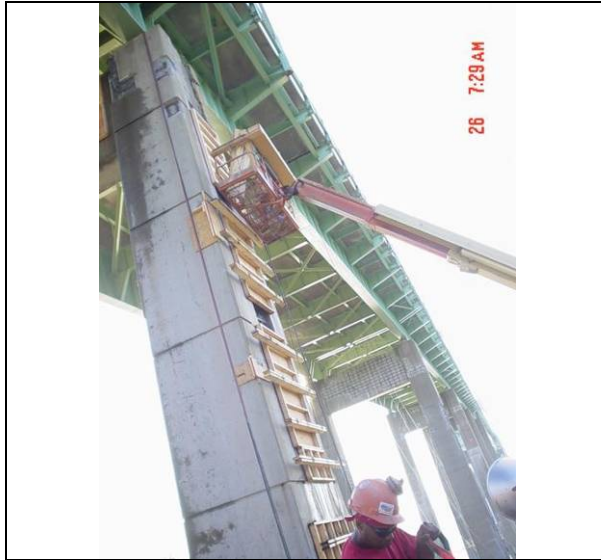
**Photo No. 9.1**

**Description:** Contractor installing concrete forms on a pier column during contract 03-4.

Work performed during Contracts 01-8 and 03-4 included repairs to the land and water piers, the abutments and the anchorages (see Photo No. 9.1). Based on this work being completed the Current Ten Year Plan does not include costs for this item.

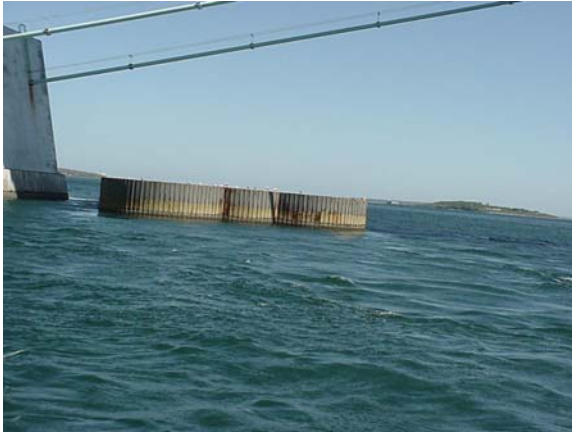
**Photo No. 10.1**

**Description:** *West Protection Cells with protective splash zone coating.*

splash zone area in 1996. The splash zone areas are prone to corrosion due to exposure to wetting and drying under tidal and wave action. In 1997 the East and West Protection Cells were repaired, with the heavier corroded East Cells being jacketed by concrete. The West Protection Cells had a special protective splash zone material applied at that time. Photo 10.1 (taken recently) shows the existing splash zone compound on the West Protection Cells is beginning to deteriorate, and continued corrosion of the steel is taking place in these areas. The Ten Year Plan includes a provision to place concrete jacketing at the West Cells to preclude further deterioration.

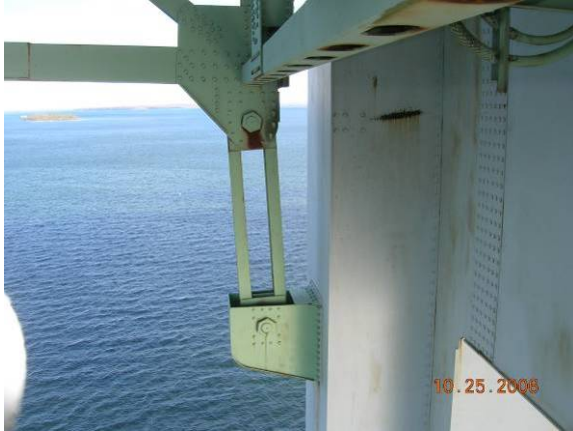
**Photo No. 14.1**

**Description:** Tower 1 East, Northwest Compression Link.

The purpose of the links is to maintain the vertical alignment of the roadway between the tower and the suspended span. The links transfer vertical load from the truss to the tower (See Photo No. 14.1).

Future repairs to the compression links are anticipated based on the historical performance of these elements and have been included in the Ten Year Plan. Three conditions, first observed during the 1989 In-Depth Inspection, have required repairs and are given special emphasis and are monitored on an annual basis.

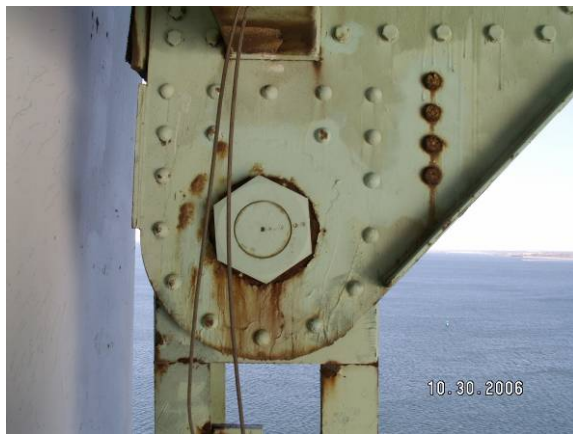
**Photo No. 14.2**

**Description:** Tower 1 West, Northeast Compression Link, Upper Inside Pin. Drilled dimples in the pin and pin nut, nominally at the 3 o'clock position permit tracking of the relative movement of the pin and the pin nut.

movement between the pins and the pin nuts. Whereas rotational movement of the pin assemblies is necessary for the compression links to perform as designed, the pin nuts should rotate as a unit with the pins (see Photo No. 14.2).

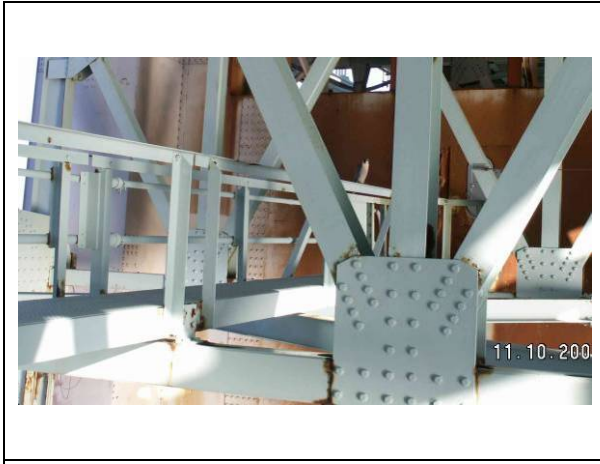
**Photo No. 18.1**

**Description:** *West Side Span, Panel Point 30 West, North Catwalk. General view of existing catwalk and safety railing.*

The original safety railing on the catwalk, that is located below the roadway deck in the suspended spans, does not meet the current Occupational and Safety and Hazard Administration (OSHA) guidelines (see Photo 18.1).

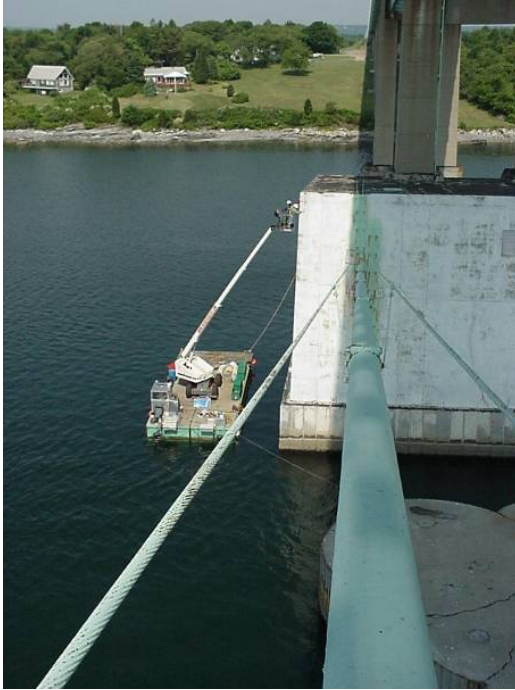
**Photo No. 19.1**

**Description:** West Anchorage, Pier 4 West. Engineers inspecting concrete on the south face of the anchorage with a barae mounted man-lift.

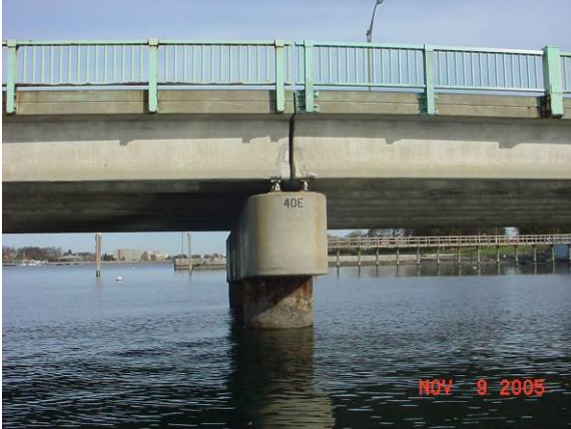
**Photo No. 24.1**

**Description:** Pier 40 East in the pre-stressed concrete beam spans in the east approach.

The 20 approach spans on the east end of the bridge near Newport are pre-stressed concrete beam spans supported on double column pier bents (see Photo No. 24.1).
